P&D Monitoring Report Hanna Ridge Vineyard

2022-23

Block A Pinot Gris

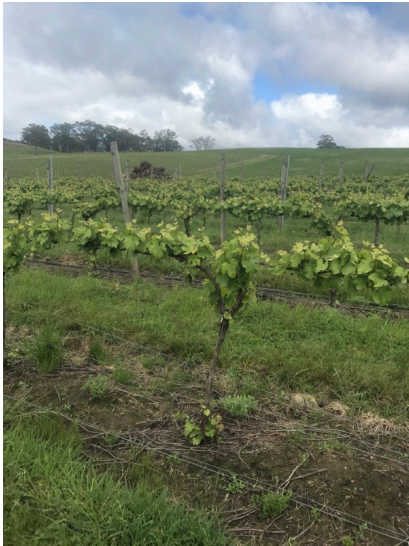
Fairly even shoot growth (image 1), some dense crowns (image 3), some blind budding (image 4).

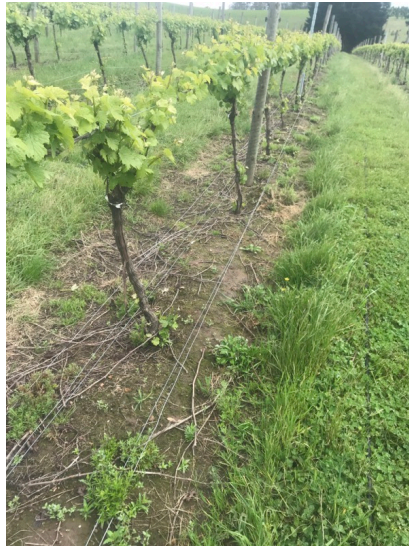
Some watershoots (image 2)

Fairly clean (image 2)

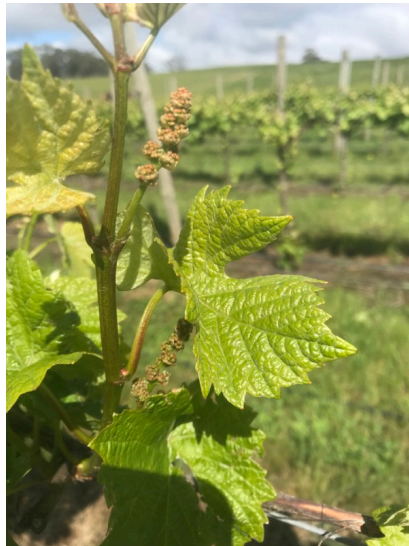
Small to medium size (image 5), medium to high density.

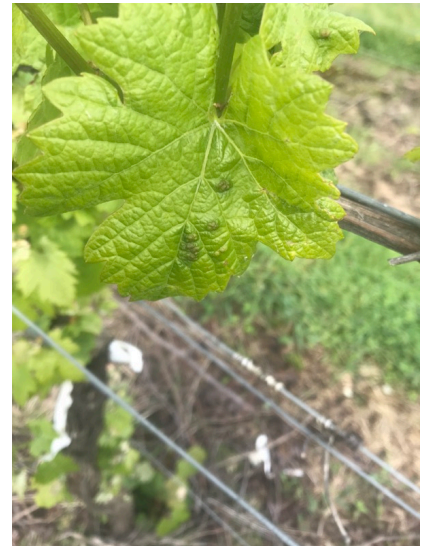
Some blister mite (image 6).

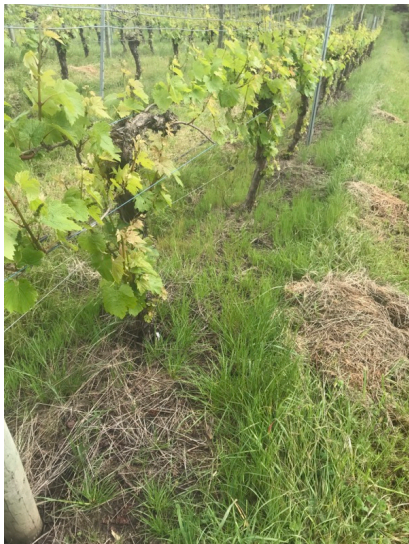
Some big watershoots (image 2).

Fairly clean (image 2)

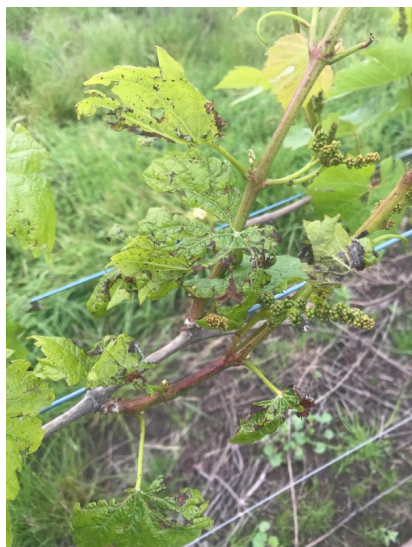
Some patches (image 4).

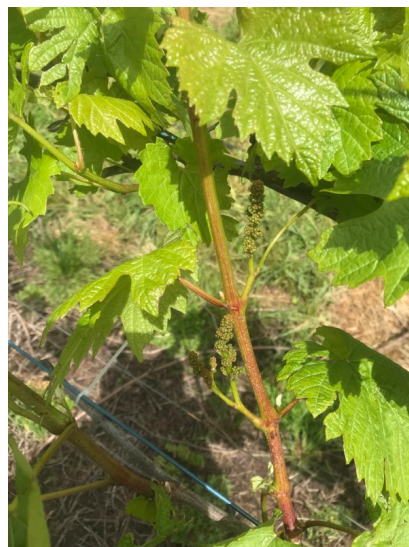
Medium size bunches (image 6), low to medium density- some blind budding, some gaps (image 7).

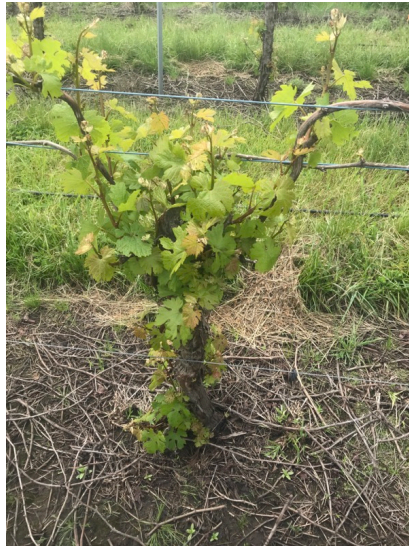
Light canopy (image 1), some dense crowns (image 8).

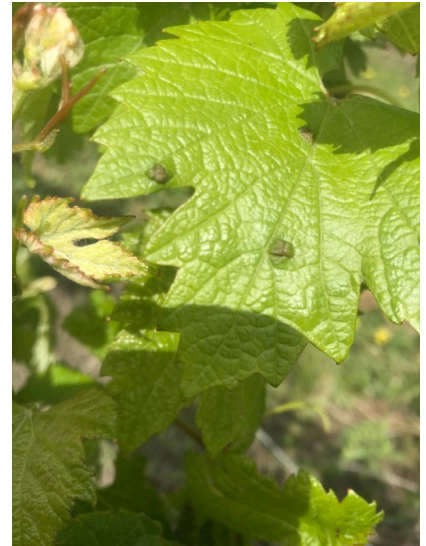
Some blister mite (image 9)

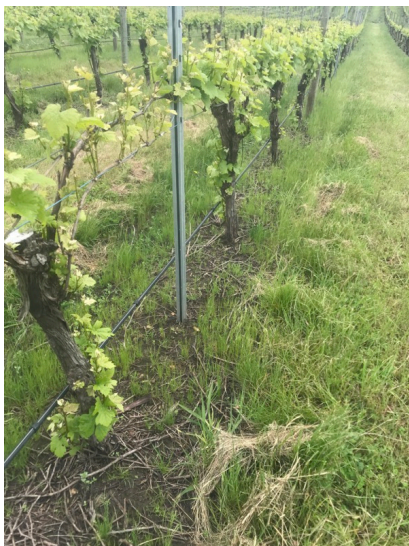
Some big watershoots (image 2)

Fairly clean (image 2)

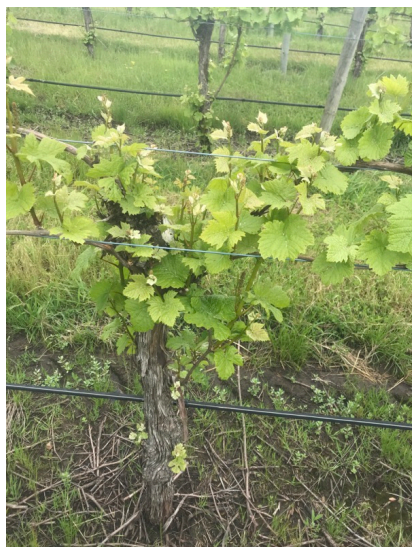
Fairly even shoot growth (image 1), some blind budding, some dense crowns (image 4)

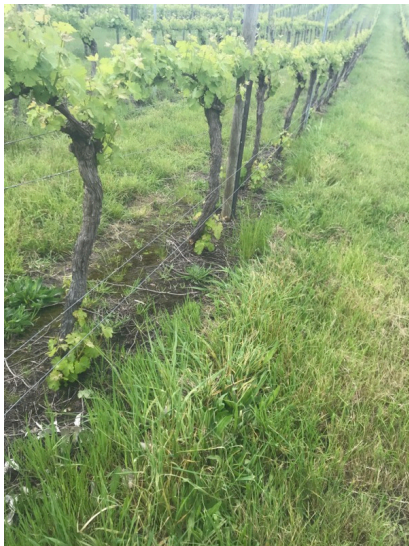
Some watershoots (image 2)

Fairly clean (image 2)

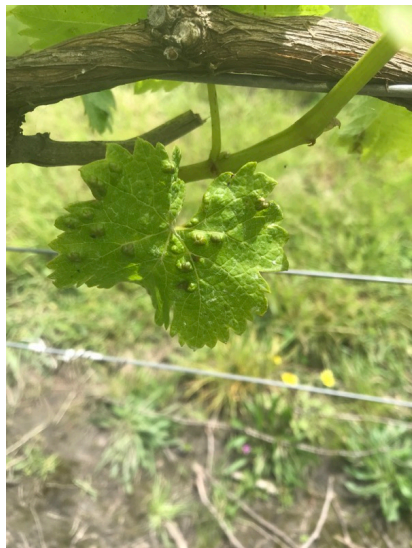
Quite a lot of blister mite (image 4)

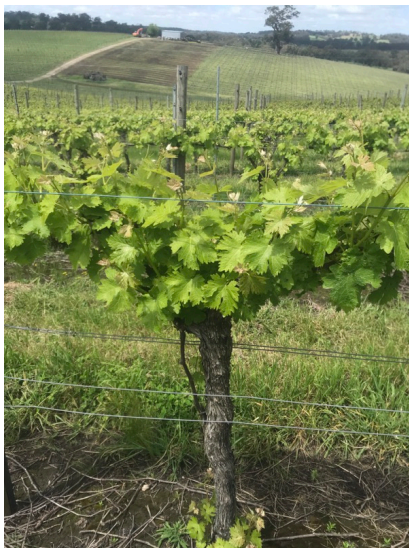
Fairly even shoot growth (image 1), some dense crowns (image 5)

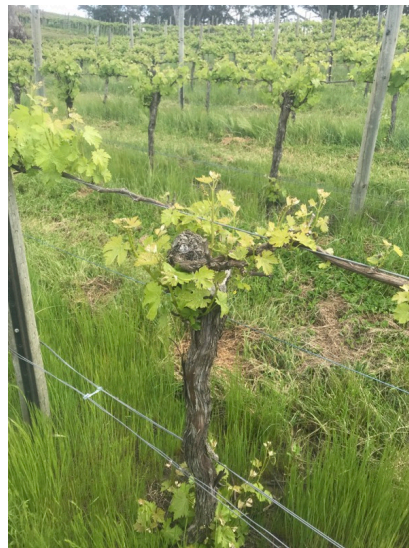
Some patches (image 6), generally not showing up on the canes

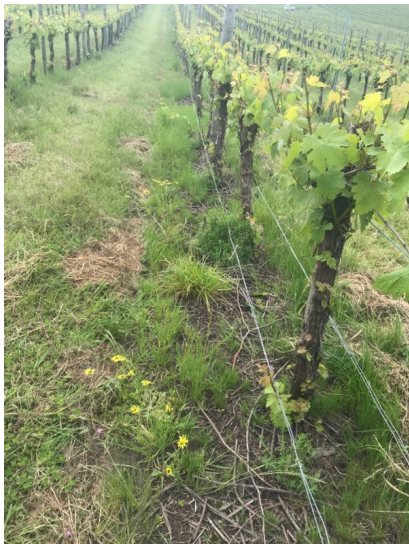
Some watershoots (image 2)

Fairly clean (image 2)

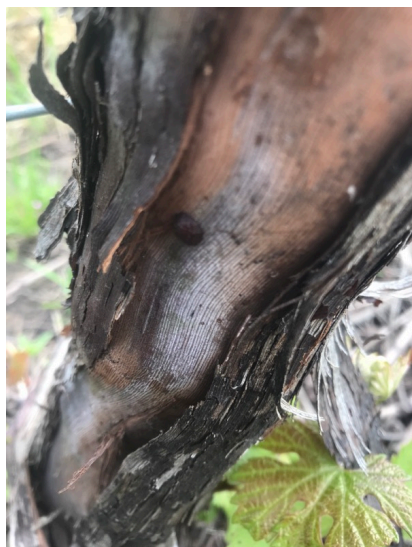
Some Scale (image 4)

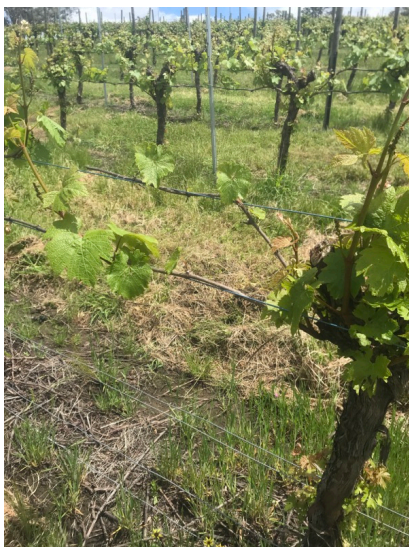
Light density (image 5)

Medium size (image 3), light to medium density-some apical dominance, blind budding (image 5).

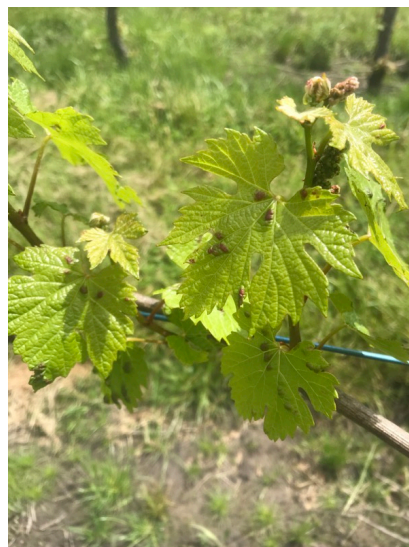
Some blister mite (image 6)

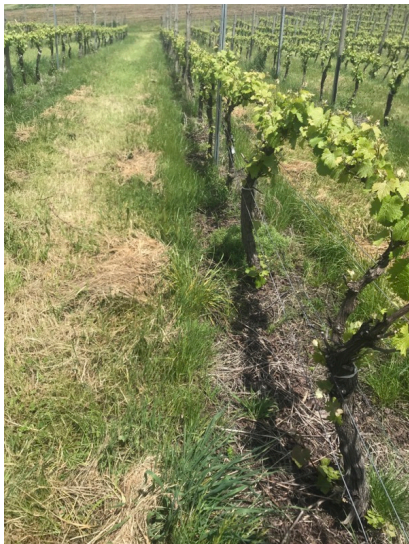
Some watershoots (image 2)

Fairly clean (image 2)

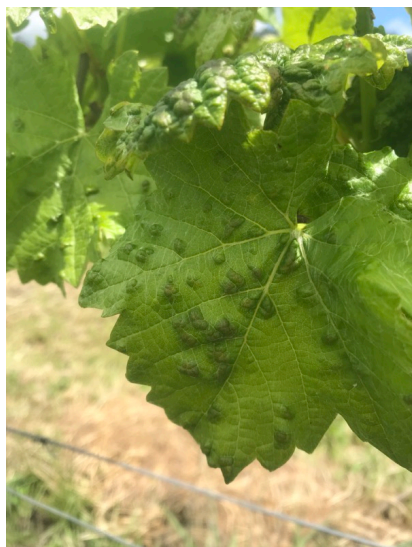
Some blister mite (image 4)

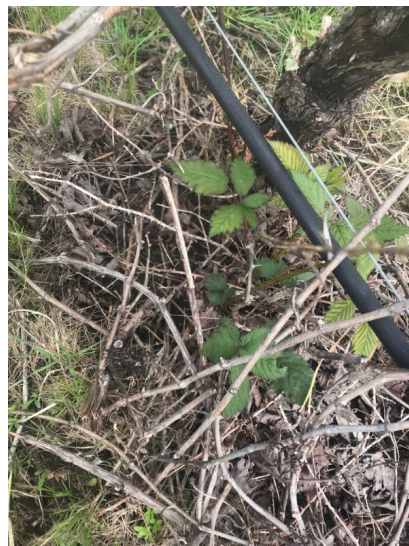
Fairly clean, some blackberry (image 3)
